**DEPARTMENT OF TRANSPORTATION**

Contract #: 04-0120F4Cty: SF/ALA Rte: 80 PM: 13.2/13.9File #: 69.28**WELDING INSPECTION REPORT****Resident Engineer:**Siegenthaler, Peter**Address:** 333 Burma Road**City:** Oakland, CA 94607**Report No:** WIR-026047**Date Inspected:** 13-Jul-2011**Project Name:** SAS Superstructure**OSM Arrival Time:** 700**Prime Contractor:** American Bridge/Fluor Enterprises, a JV**OSM Departure Time:** 1900**Contractor:** Zhenhua Port Machinery Company, Ltd (ZPMC), Changxing Island **Location:** Shanghai, China

<b>CWI Name:</b>	N/A	<b>CWI Present:</b>	<b>Yes</b>	<b>No</b>			
<b>Inspected CWI report:</b>	<b>Yes</b>	<b>No</b>	<b>N/A</b>	<b>Rod Oven in Use:</b>	<b>Yes</b>	<b>No</b>	<b>N/A</b>
<b>Electrode to specification:</b>	<b>Yes</b>	<b>No</b>	<b>N/A</b>	<b>Weld Procedures Followed:</b>	<b>Yes</b>	<b>No</b>	<b>N/A</b>
<b>Qualified Welders:</b>	<b>Yes</b>	<b>No</b>	<b>N/A</b>	<b>Verified Joint Fit-up:</b>	<b>Yes</b>	<b>No</b>	<b>N/A</b>
<b>Approved Drawings:</b>	<b>Yes</b>	<b>No</b>	<b>N/A</b>	<b>Approved WPS:</b>	<b>Yes</b>	<b>No</b>	<b>N/A</b>
				<b>Delayed / Cancelled:</b>	<b>Yes</b>	<b>No</b>	<b>N/A</b>
<b>Bridge No:</b>	34-0006	<b>Component:</b>	OBG Tria

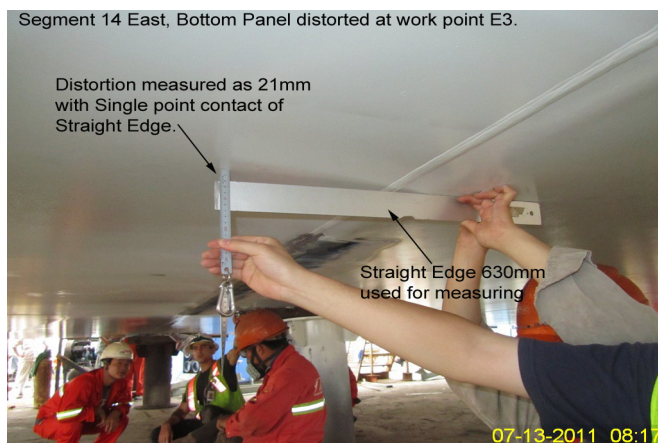
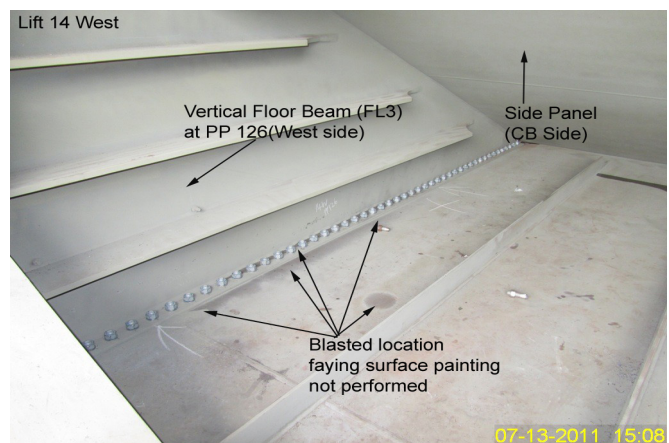
Incident Report generated at Lift 14 East (Bottom Panel)

This Quality Assurance (QA) Inspector wrote an Incident Report for addressing the Bottom Panel, distorted locations at work point E3. Please reference the Incident Report #

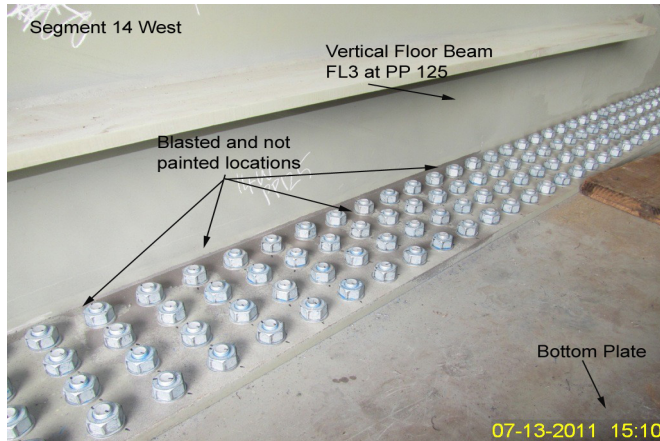
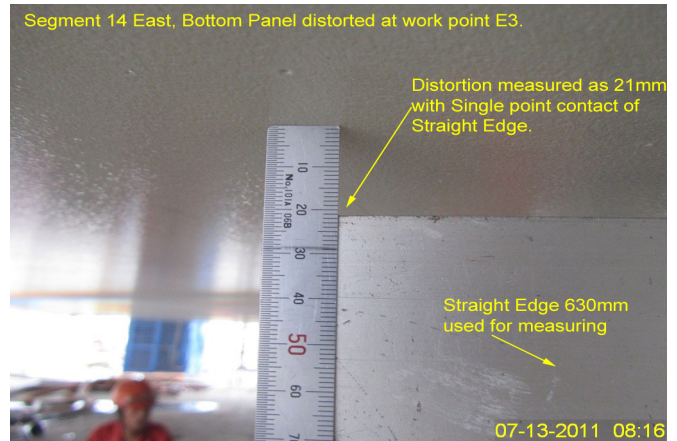
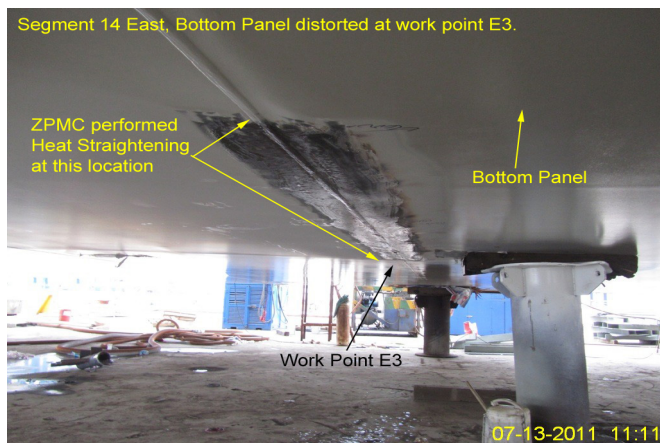
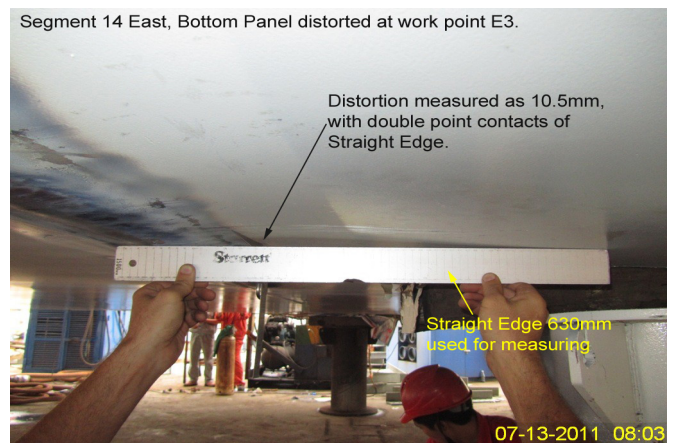
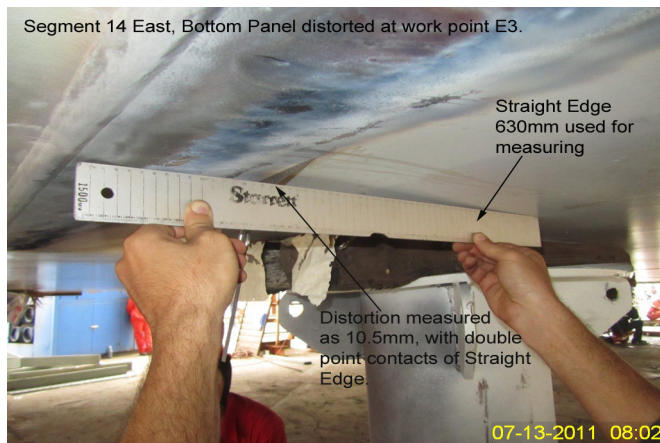
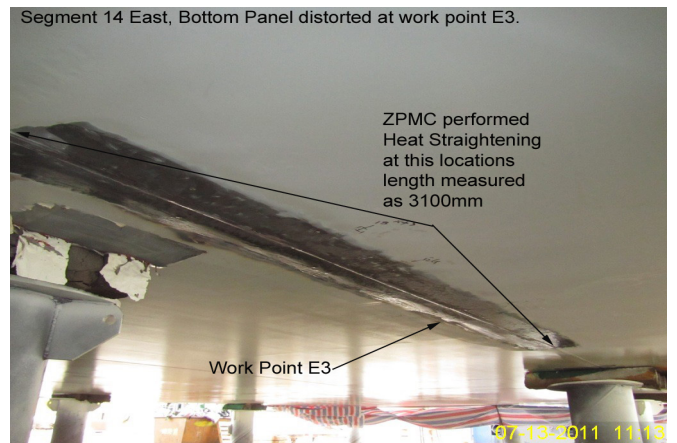
Prior to verifying the tension verification QA Inspector performed the Visual Inspection (VT) for the bolt assemblies installed location and observed that painting was not performed at the faying surfaces where the bolts were installed.

Blasting mark was traced at PP 125 and PP 126, west side of the vertical floor beam, asked the ZPMC QC Mr. Zhang Hai Jung to remove the bolts, get paint applied and installed fresh bolts and re-offer for inspection. ZPMC QC agreed for the same.
